**Subject:** LRV(b) RIDER CLUTCH ADJUSTMENT

**Complaint:** Unit will not move or clutch slips.

**Solution:** Adjust loose clutch on LRV(b) rider.

**Models Affected:** LRV(b) RIDERS

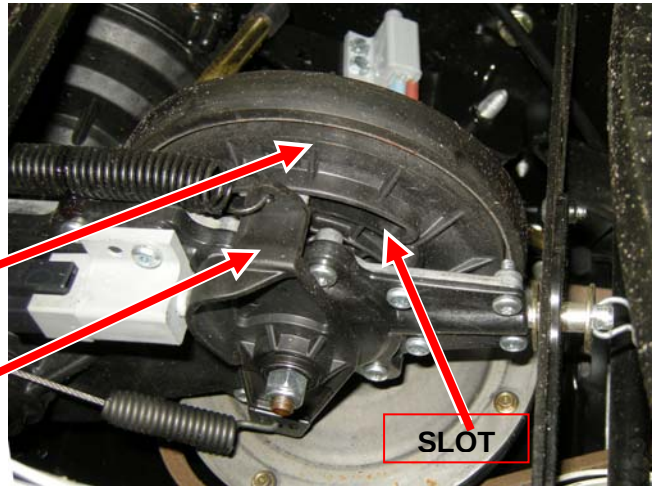
8. Locate the slot in the left clutch cover.

L.H. CLUTCH COVER

BRAKE ARM

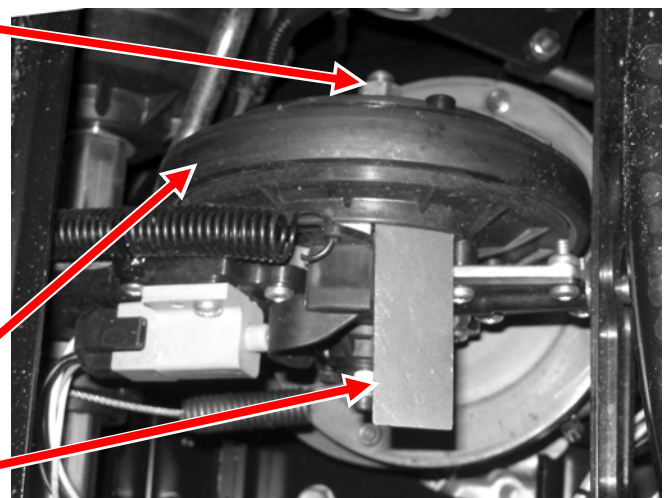
ADJUSTMENT NUT

FRICTION WHEEL

GAUGE

9. Insert the gauge into the slot while making the adjustment.

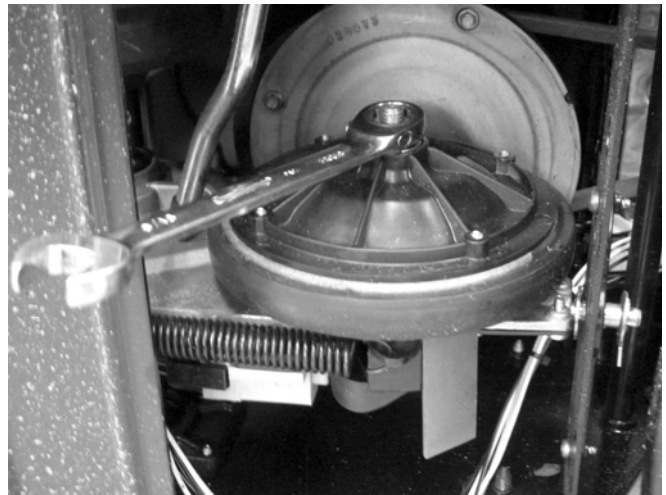
**NOTE:** If the nut bottoms out before the brake arm is tight against the gauge there is no more adjustment.

10. Hold the friction wheel while tightening the adjustment nut until the gauge is lightly clamped between the brake arm and the slot in the clutch cover.

- Remove the gauge.
- Test drive the rider.

- When there is no more adjustment and the rider does not perform adequately, replace the 443885 Primary Reduction Assembly with Clutch.
