Service Bulletin

Product: Select 2015 Tillers

Text: Reference **SB# B1500042**

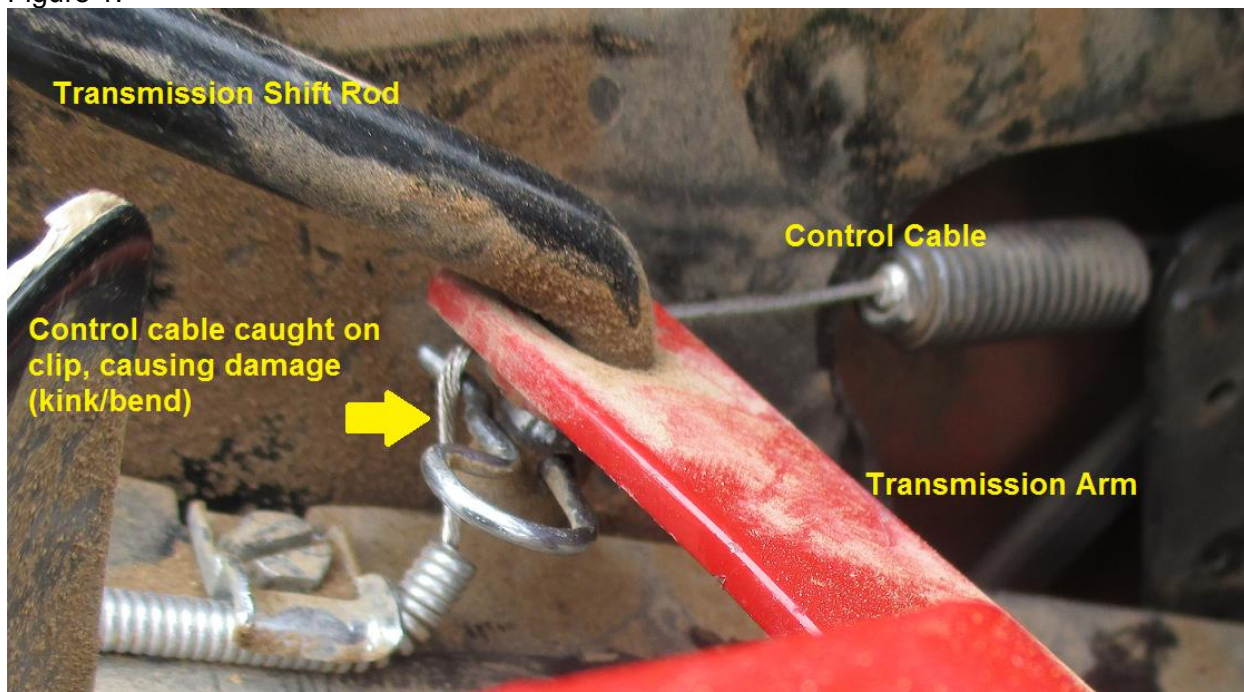
The transmission shift rod and clip are making contact with the control cable when shifting the transmission. This can cause the control cable to become kinked and/or caught, resulting in unintended engagement. See Figure 1.

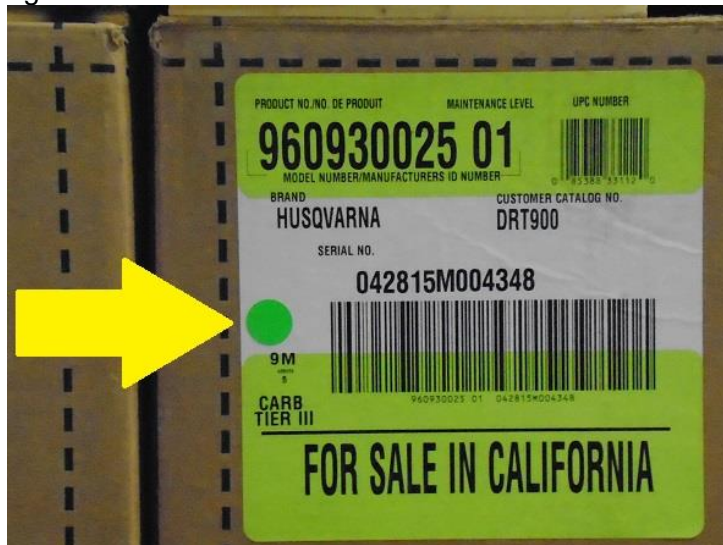
If the unit has a small green circle on the label as shown in Figure 2 below, the tiller has been reworked at the factory/warehouse and does **not** require service as described in this document.

Figure 2 – Indicator of reworked unit

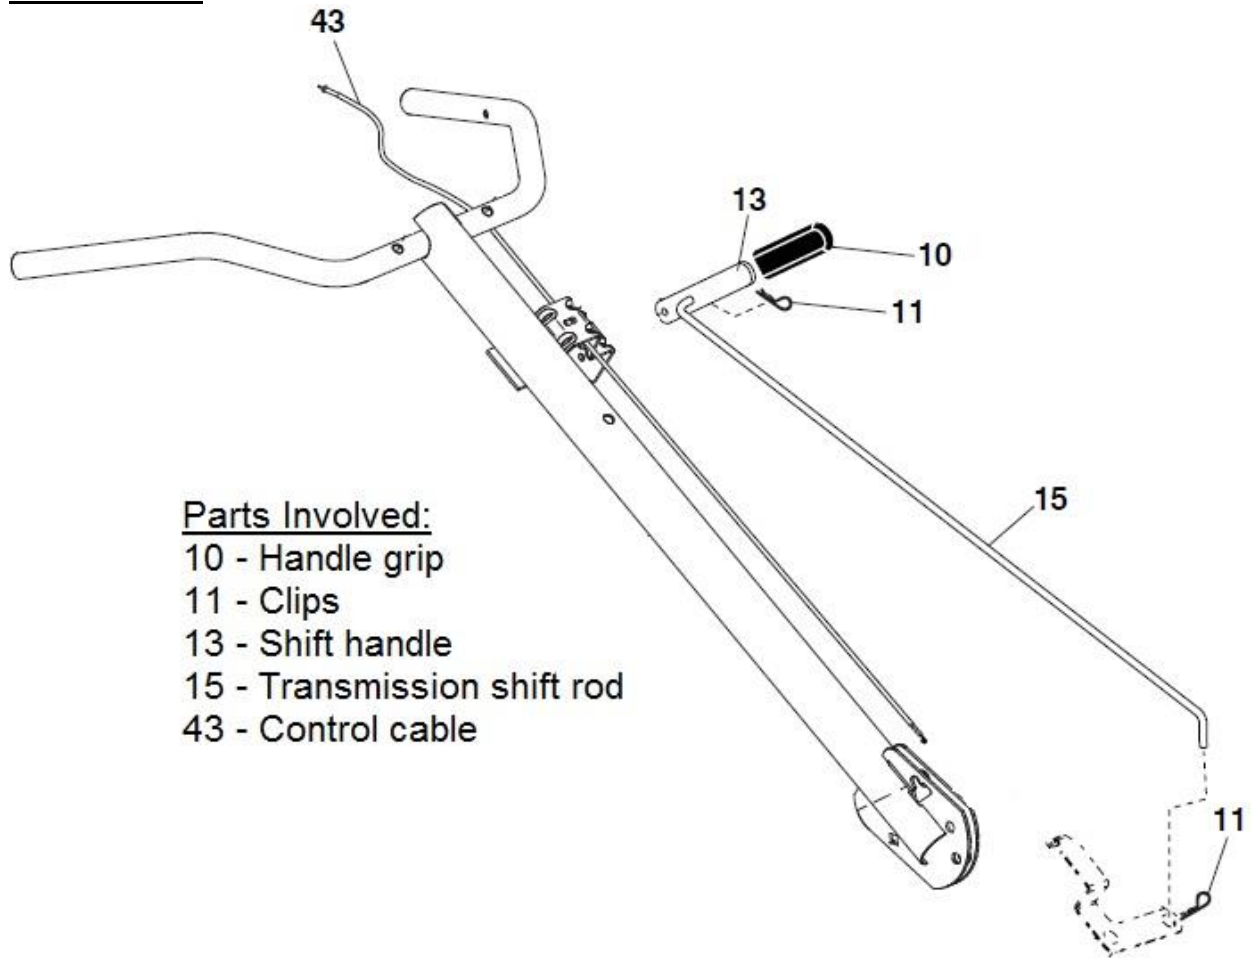
- 10 - Handle grip
- 11 - Clips
- 13 - Shift handle
- 15 - Transmission shift rod
- 43 - Control cable

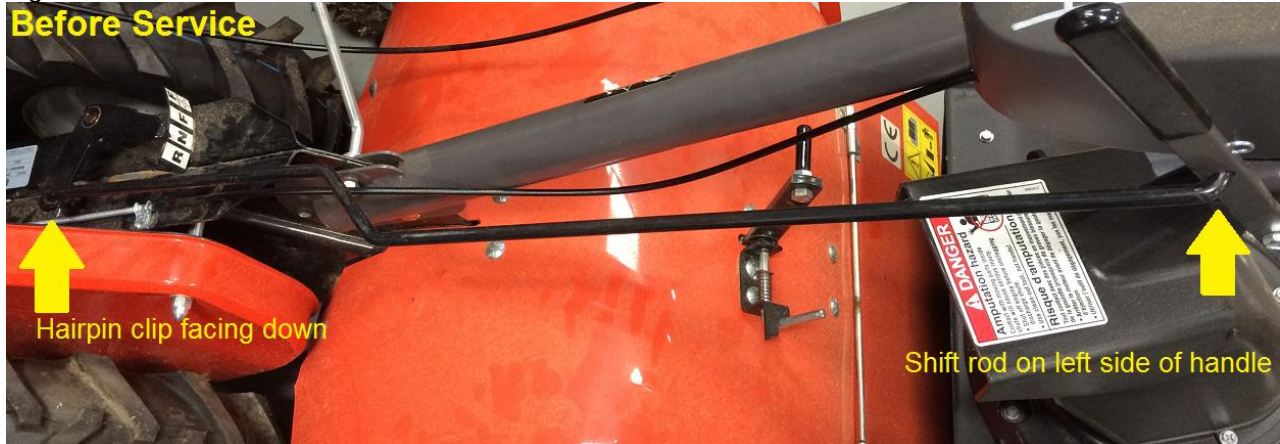
Note the position of the clip at each end of the transmission shift rod. Before service, the clip is facing down at the transmission end and the transmission shift rod enters the handle from the LH side. See Figures 3a, 3b and 3c.

Figure 3a – Before Service

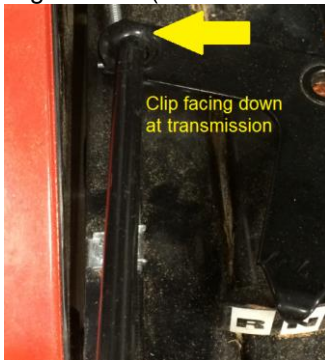
Figure 3b – (transmission end)

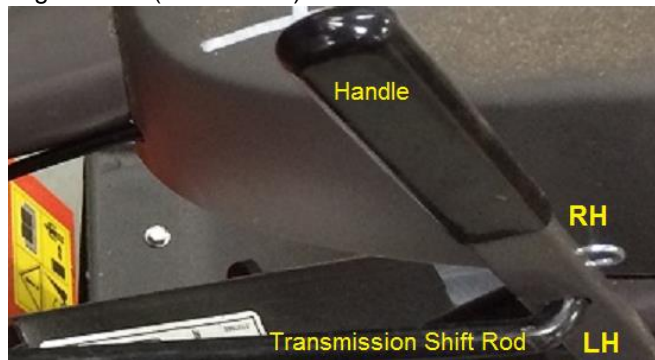
Figure 3c – (handle end)

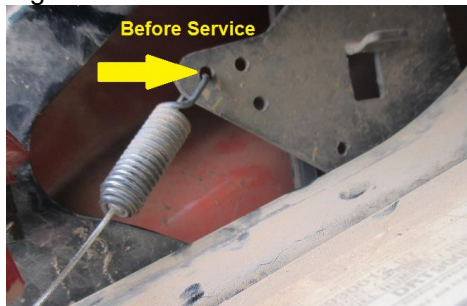
Note the position of the control cable. Before service, the cable is attached to the idler bracket through the top hole, as indicated in Figure 4. Note that the open end of the spring is facing the belt.

Figure 4 – Control cable connection

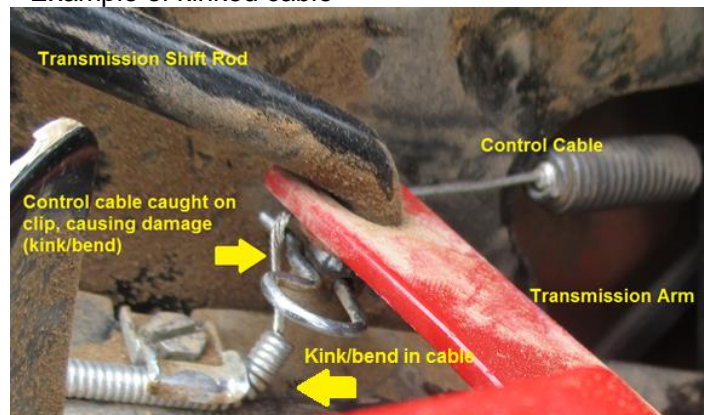
Figure 5a – Example of kinked cable

- 4. Inspect cable for any damage (such as kinks, bends, breaks). If damaged, replace cable. See Figures 5a, 5b and 5c for examples.

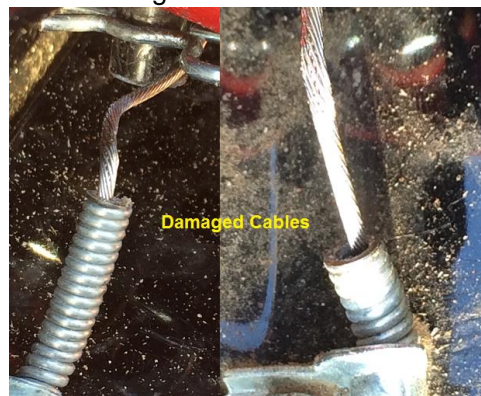
Figure 5c – Damaged cables

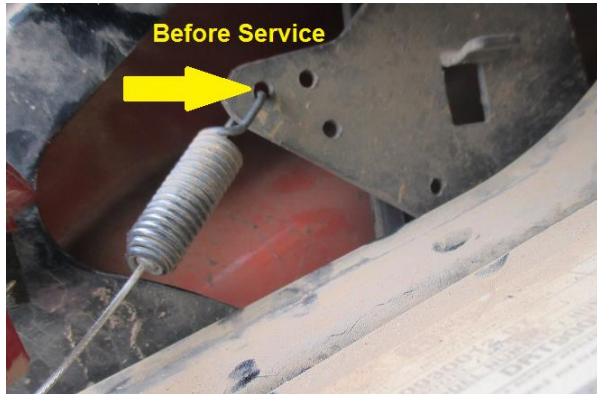
Figure 6 – Control cable positioned in top hole

5. Disconnect cable from top hole in idler bracket. See Figure 6. Note: This will require loosening the screw that holds the cable. Move the shifter arm to allow access to the screw that holds the cable.
6. Reconnect control cable to lowest hole in idler bracket with the open end of the spring facing the engine side of bracket (away from belt). See Figure 7.
7. Reset cable tension. With handle in the released position (not activated), pull cable taught. Tighten screw that holds the cable. Move shifter arm back to neutral if moved in step 5.

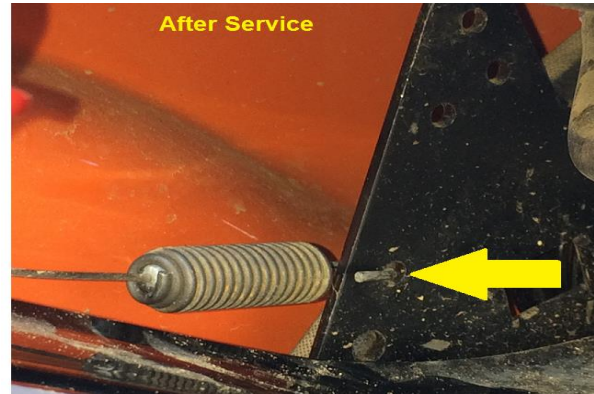
Figure 7 – Position in lowest hole

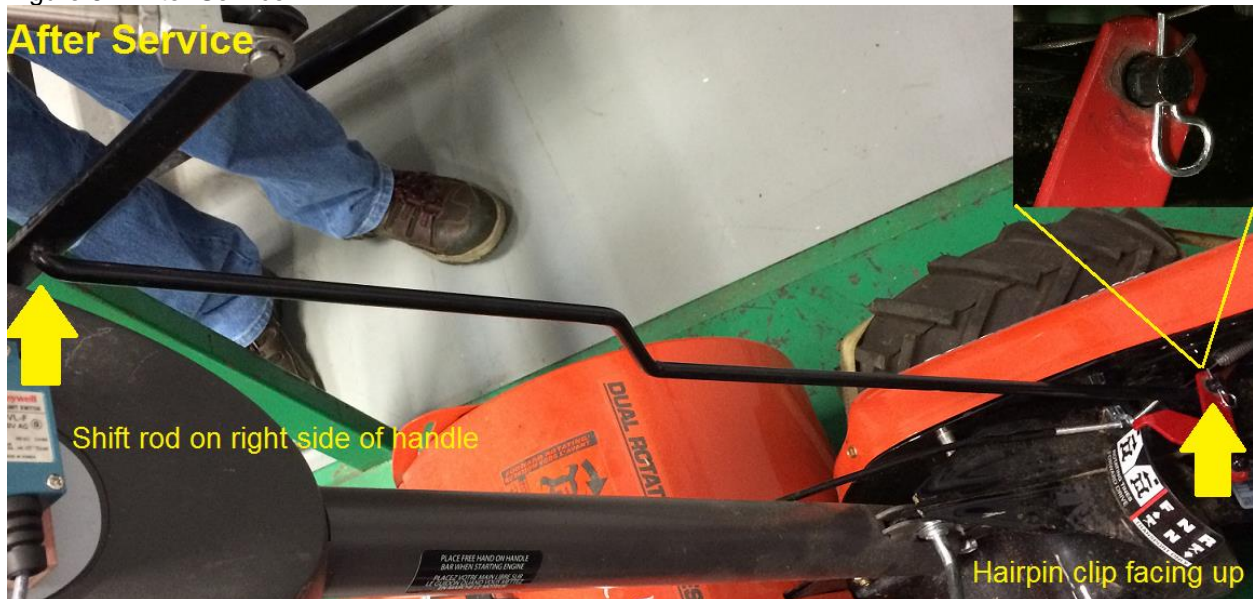
Figure 8 – After Service

8. Flip the position of the transmission shift rod so that the handle end is now near the transmission shift arm and the transmission end is near the handle.
9. Insert end of transmission shift rod to handle, entering from the RH side. Use clip to fasten into position (no washer needed).
10. Insert other end of transmission shift rod to underside of transmission shift arm, using clip on top. Fasten into position (no washer needed). The clip will now be out of contact with control cable while shifting gears.
11. Verify position of transmission shift rod is as seen in Figure 8.

12. Move gear shift handle, checking that the control cable is not making contact with the transmission shift rod and clip.
