**Subject:** LRV(b) RIDER CLUTCH ADJUSTMENT

**Complaint:** Unit will not move or clutch slips.

**Solution:** Adjust loose clutch on LRV(b) rider.

**Models Affected:** LRV(b) RIDERS

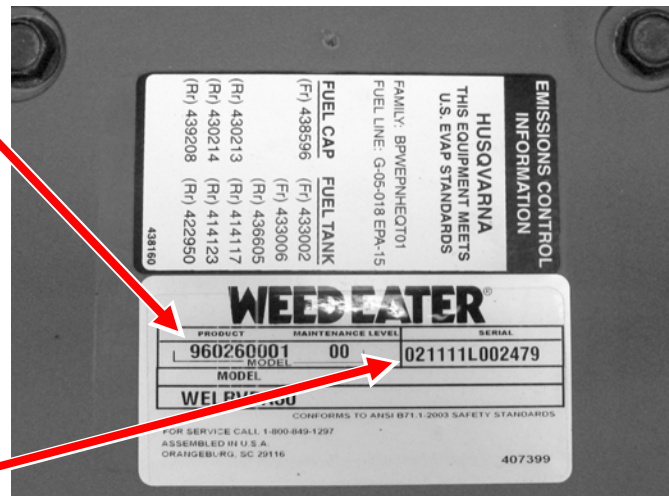
## SERIAL NUMBER

2. The model plate is located on the control panel under the seat. Record the complete product number with maintenance level and the complete serial number of the rider on the service order.

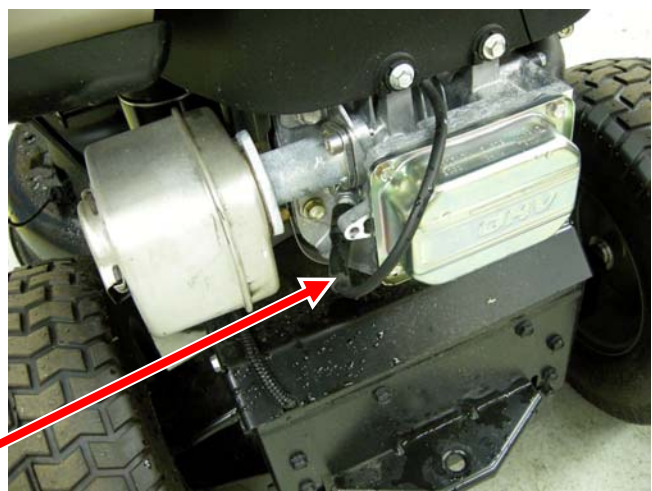
## SPARK PLUG WIRE

3. The rider must be on a level surface.
4. While working on the rider remove the spark plug wire from the spark plug.
5. Remove the ignition key while working.
6. The parking brake must be disengaged while making this adjustment.

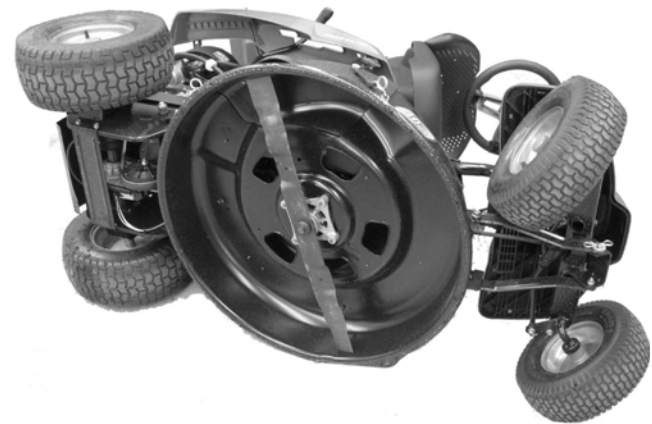
7. The adjustment can be performed from the underside of the transmission.
- The underside of the transmission can be accessed by either lifting the rider from the rear engine plate or by placing the rider on it's left side (carburetor and air filter up).
  - If you elect to place the rider on the left side, place a cover between the control panel and mower lift lever and the ground to protect from scratches and abrasion to the finishes.
